Photographic Log, CES Environmental Services Facility Site Visit, Houston, Texas

The following photographs were taken and described by Terry Andrews, Remediation Division, Texas Commission on Environmental Quality (TCEQ), while visiting the CES Environmental Services (CES) facility in Houston, Texas on August 2, 2014, from approximately 8:30 to 11:20 AM and August 12, 2014, from approximately 1:30 to 2:30 PM. The goal of both of these site visits was to investigate the source of the oily water release that had been reported on Kingsbury Ave on 8/1/2014.

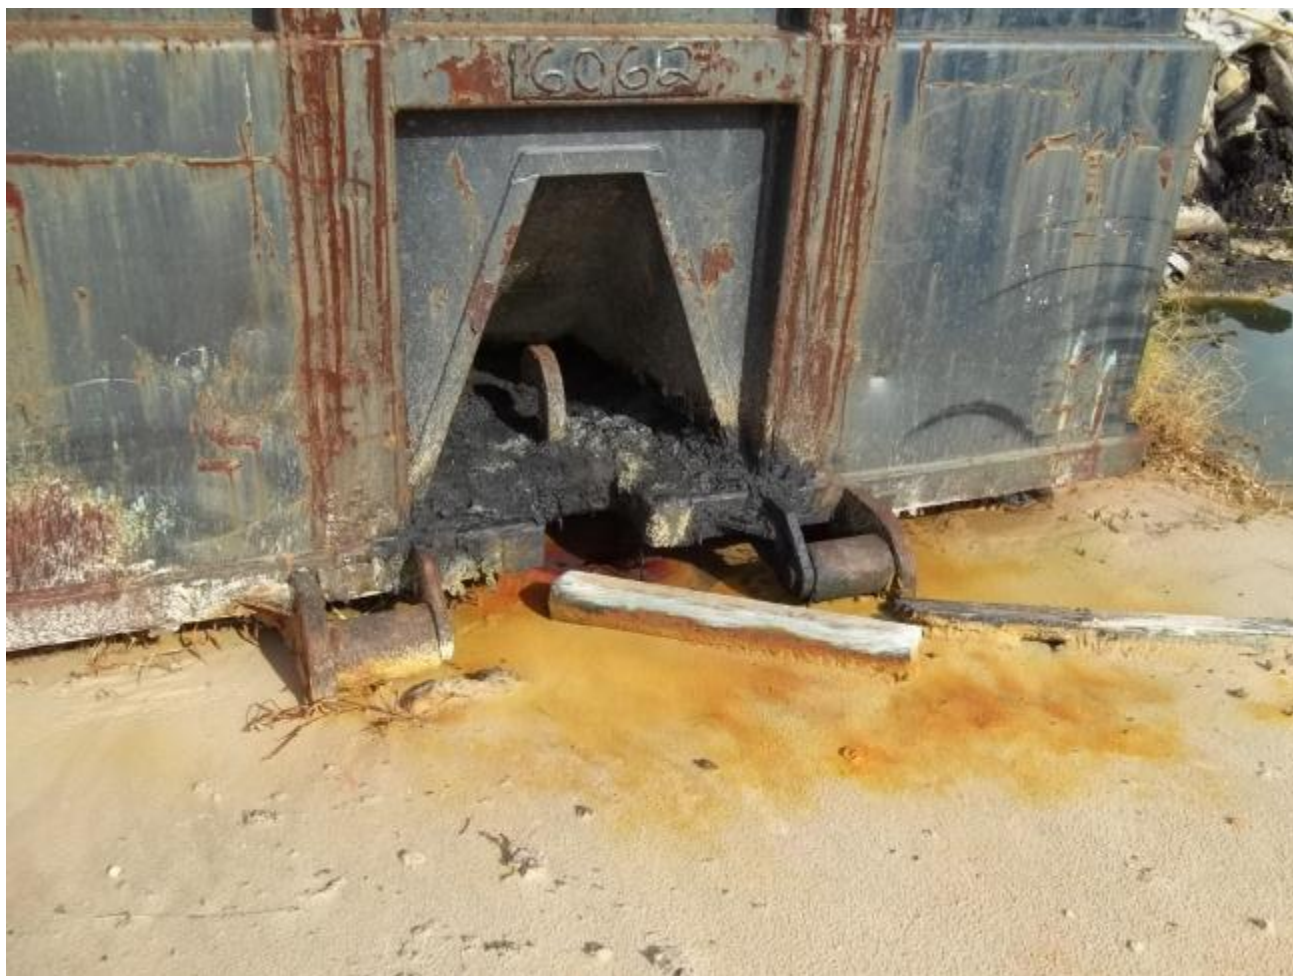
Photograph #18, August 2, 2014 - View looking west at the front of vacuum box 617. The box appears to be leaking liquid from the area near the hook in the center of the photograph.

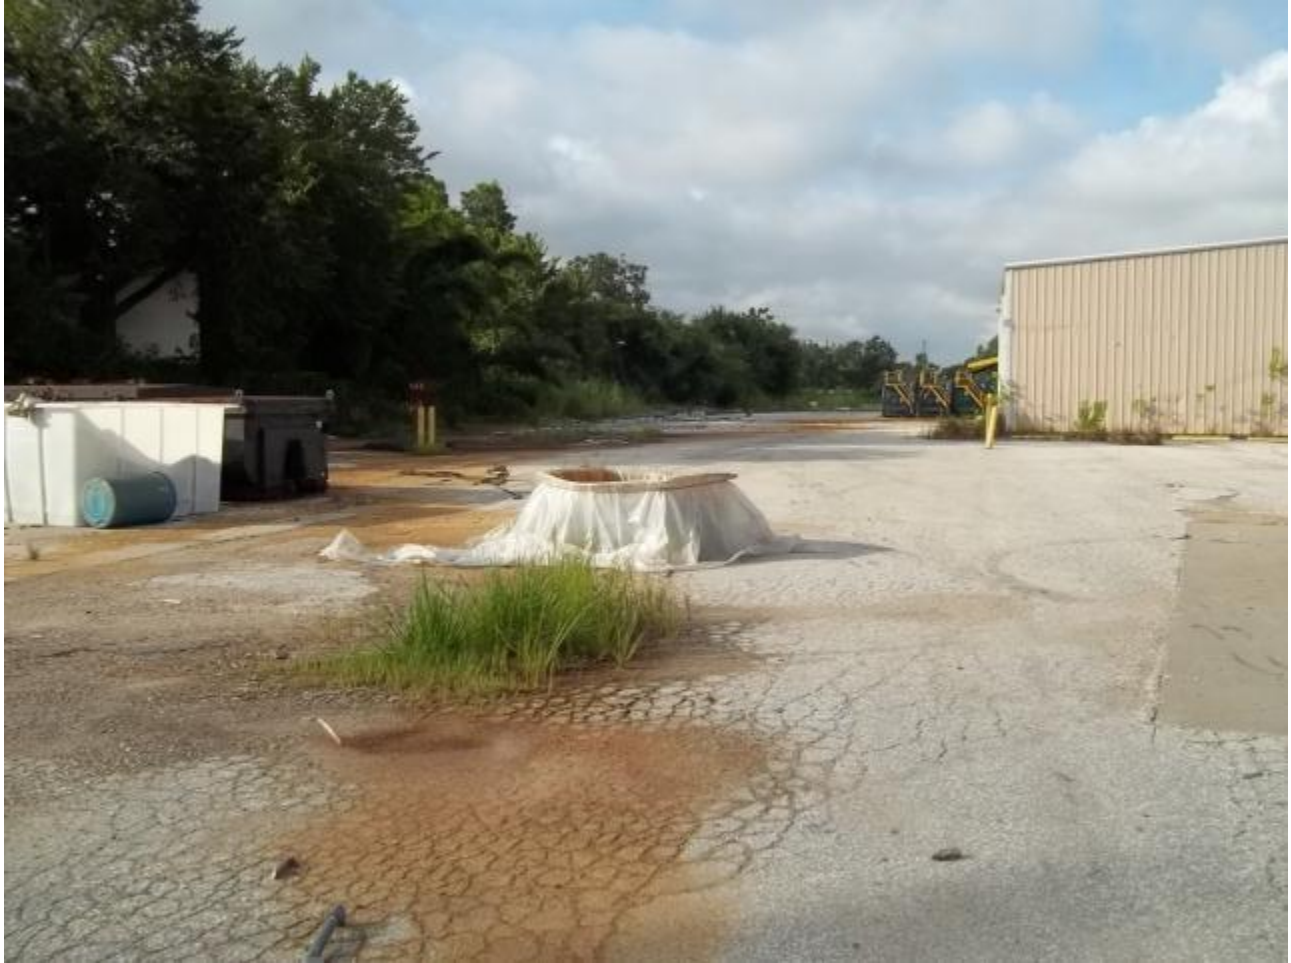
Photograph #19, August 2, 2014 - View looking south at one of the open top containers that has been temporarily covered with plastic sheeting. The container is located in the northern half of the facility. The Bay Wash Out building is in the background to the right. The east perimeter fence line is located in the undergrowth and trees. The white object that is visible in the trees and above the roll-off is the side of a neighboring house.

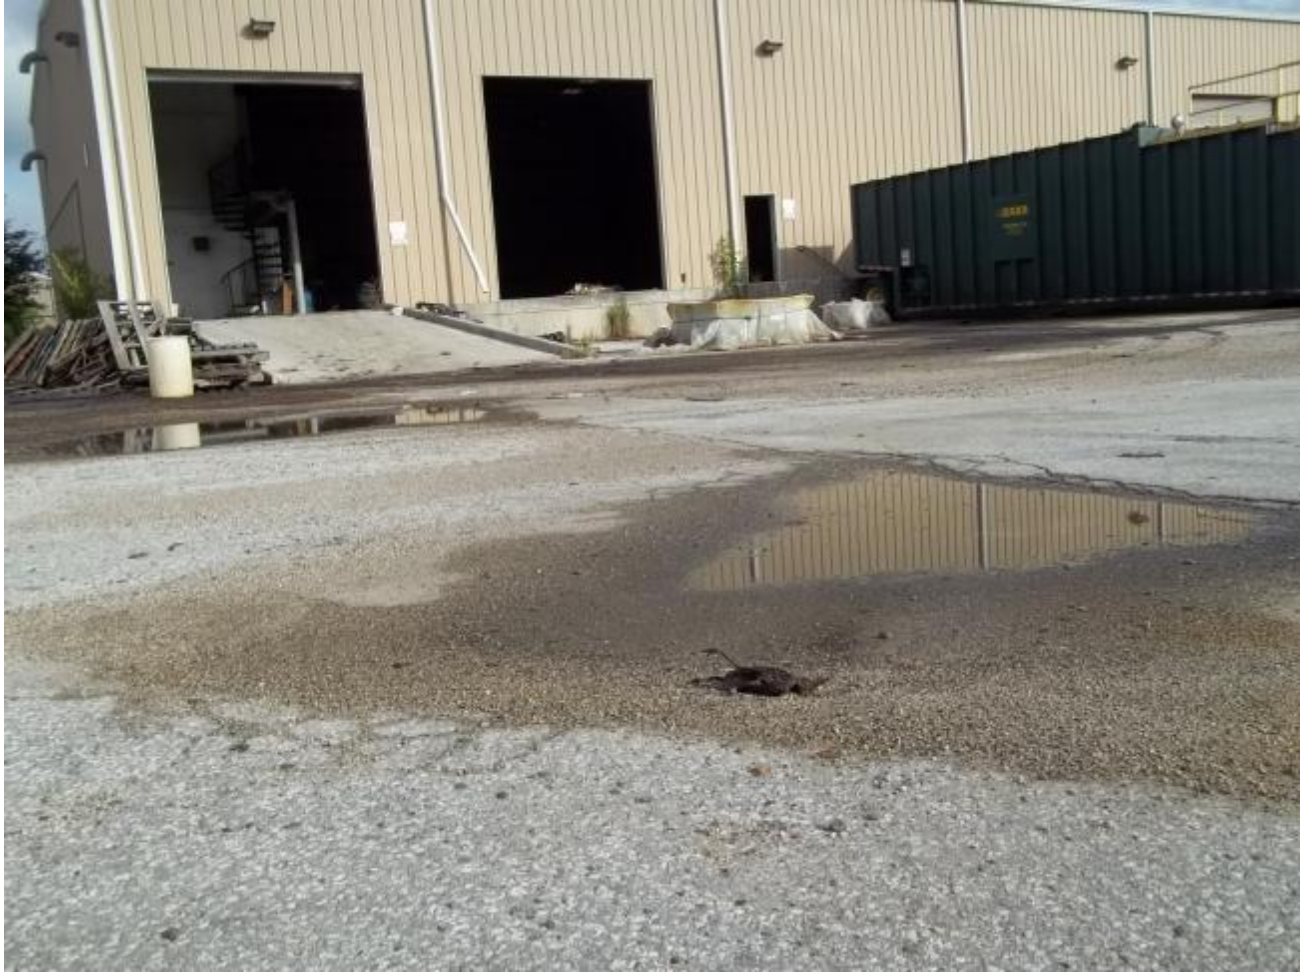
Photograph #20, August 2, 2014- View looking west at the south end of the large warehouse building. A dead bird on the pavement can be seen in the foreground. Visible behind the bird is another open top container that has been temporarily covered with plastic sheeting and a frac tank.

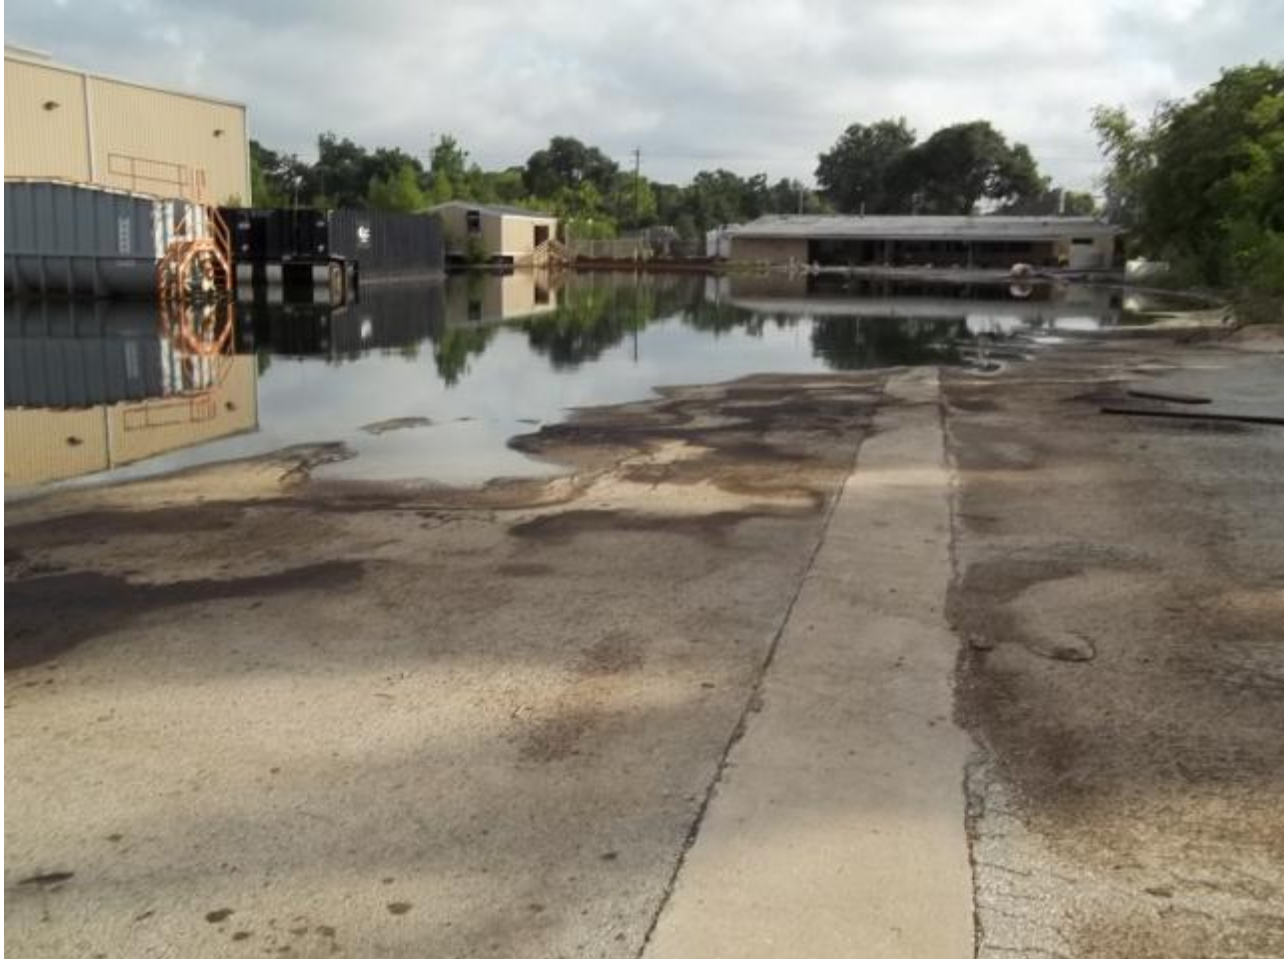
Photograph #21, August 2, 2014 - View looking north at the north end of the site. The building on the right side is the office building. The building in the middle is the Sample Receiving building. The building to the left is the warehouse building. Note the stormwater ponded on the concrete and the soil berm that has been placed along the front gate (between the office and sampling receiving buildings). Also, note three frac tanks parked near the warehouse. The east perimeter fence is located near the tree line in the far right side of the photograph.

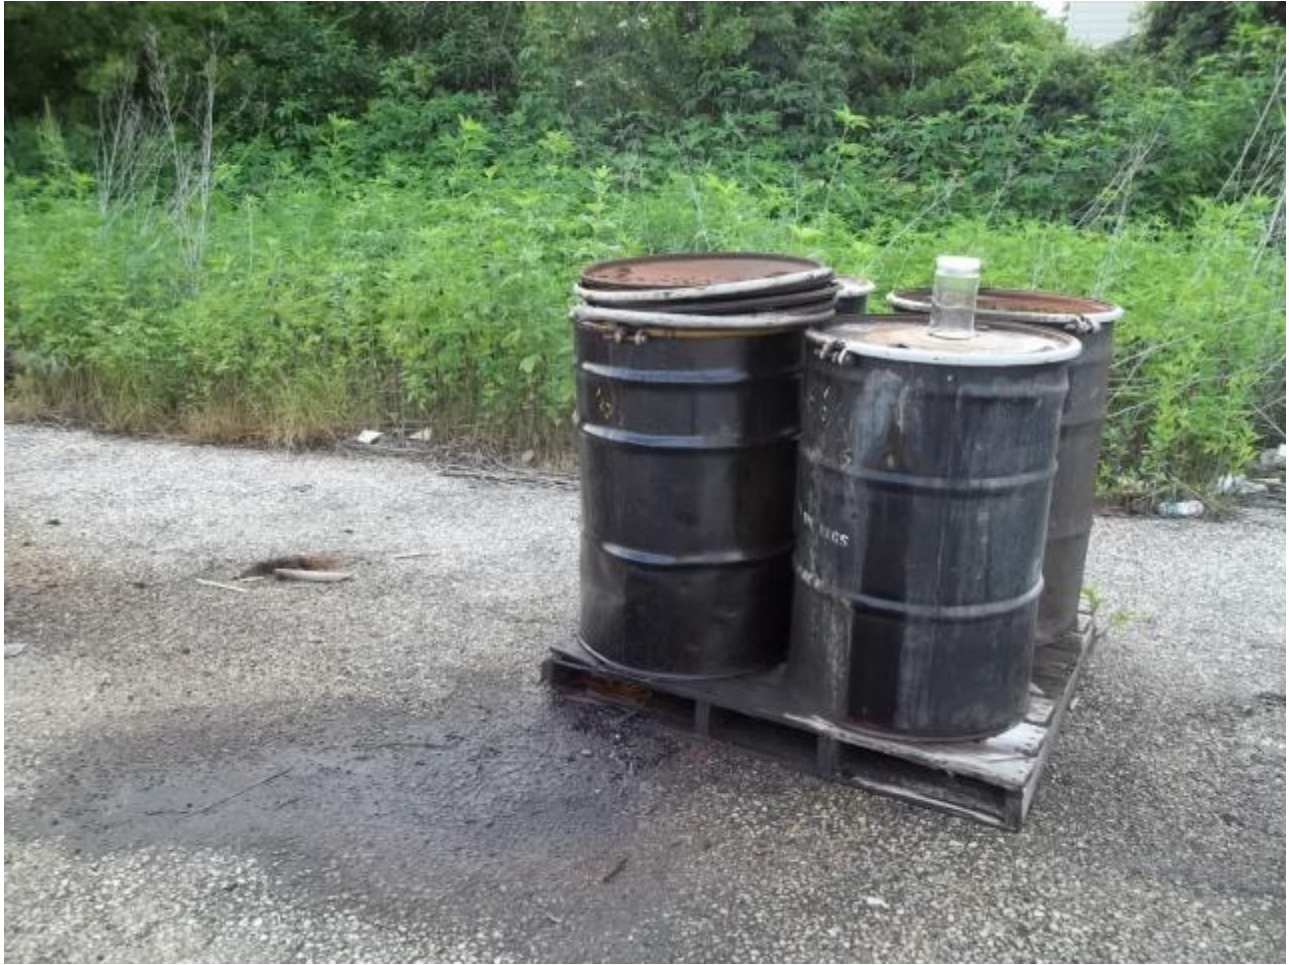
Photograph #22, August 2, 2014 - View looking east at four drums sitting on a pallet located near the eastern perimeter fence in the north part of the facility. The lid for one of the drums appears to be ajar and has leaked an oily material onto the pavement. The perimeter fence and the side of a residential home is in the background.

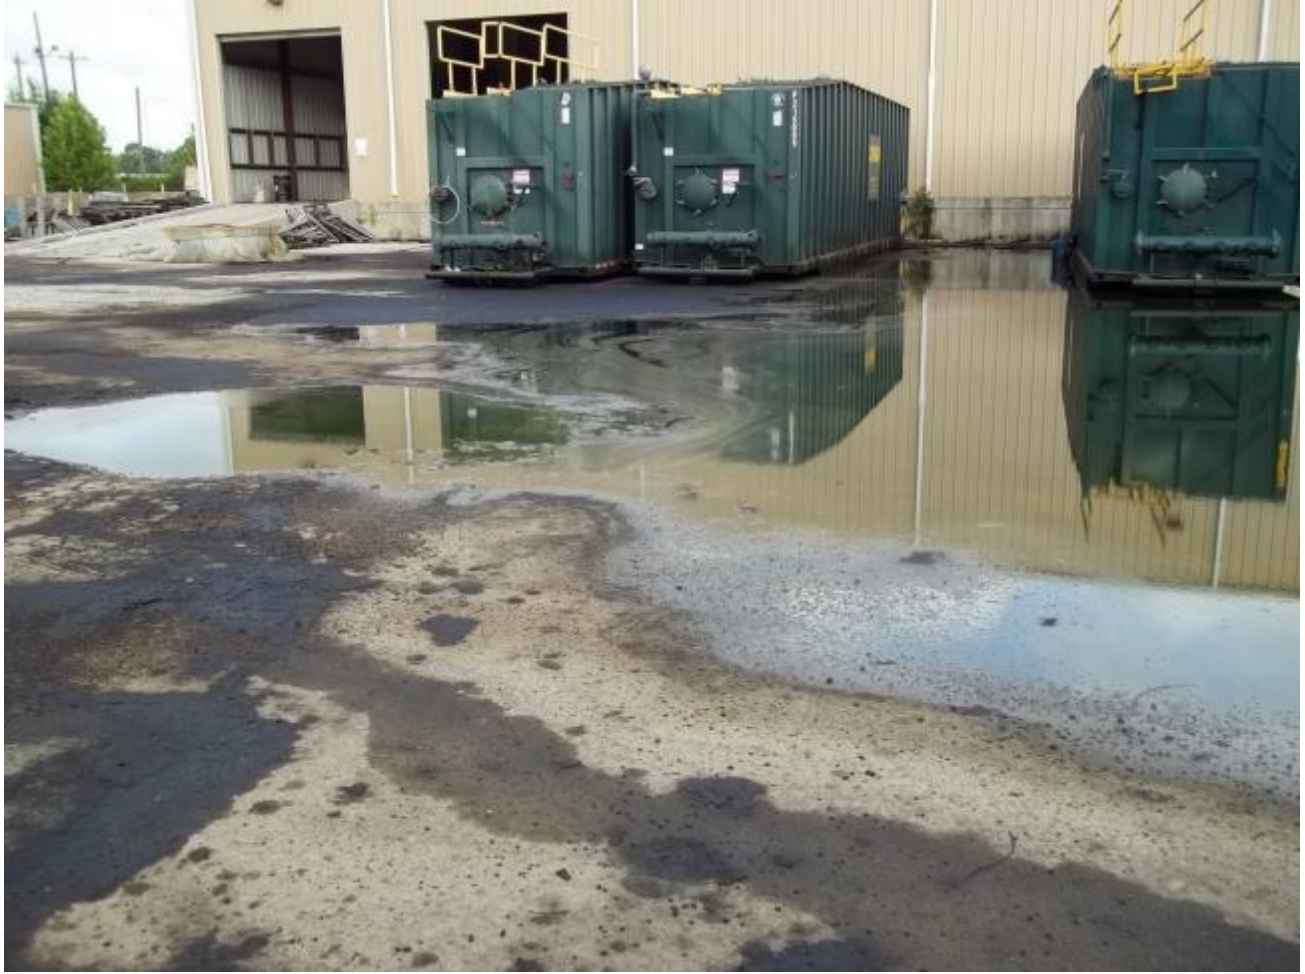
Photograph #23, August 2, 2014 - View looking west at the south end of the large warehouse building. Note the three frac tanks and the open top container (covered with plastic sheeting). The ponded water appears to have an oil scummy sheen.

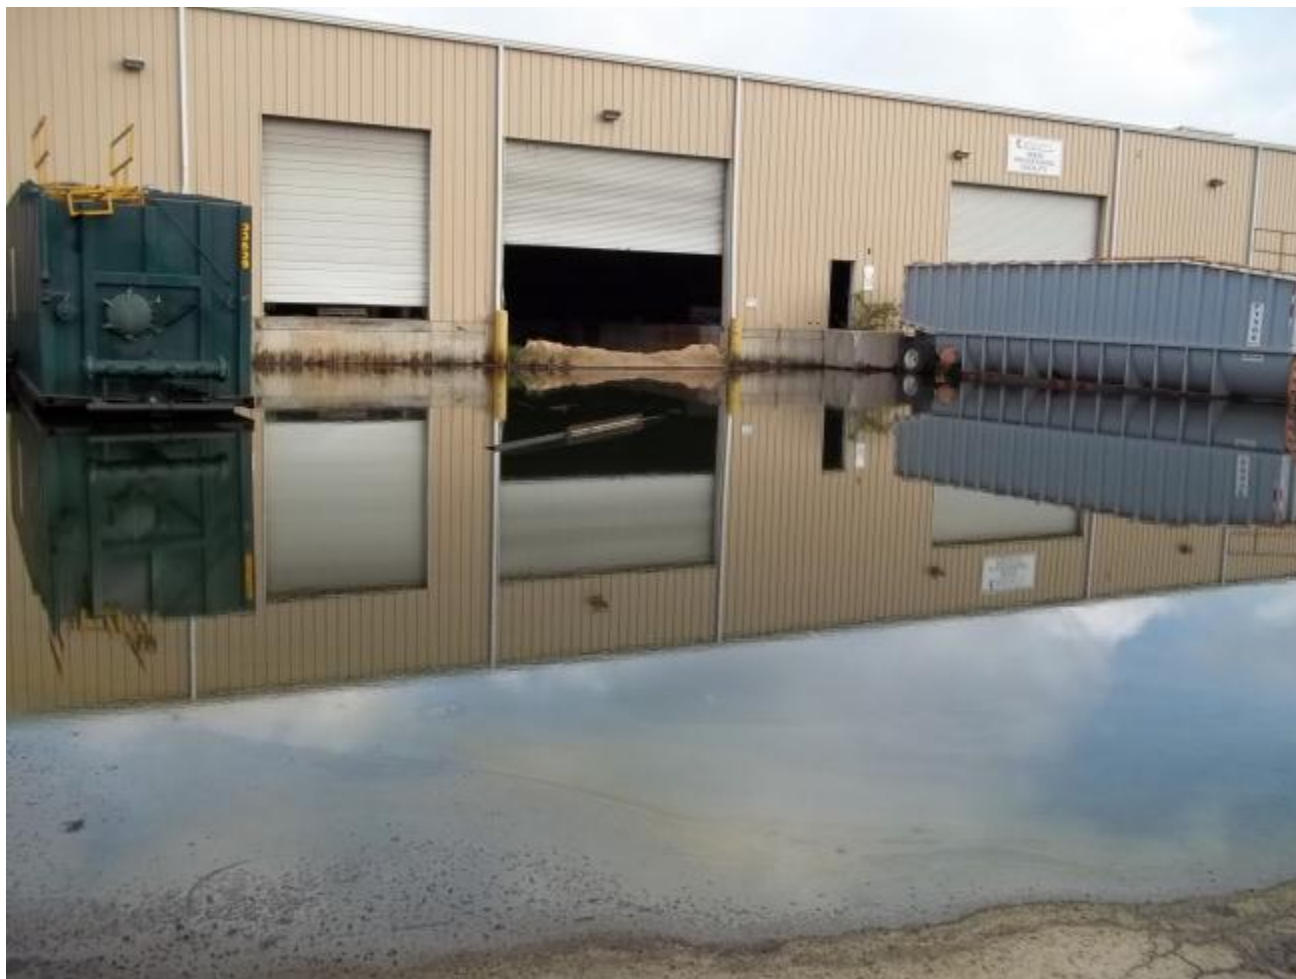
Photograph #24, August 2, 2014 - View looking west the large warehouse building. A soil berm has been placed at the loading bay door because the loading bay contains oil that is pooled within the loading bay.

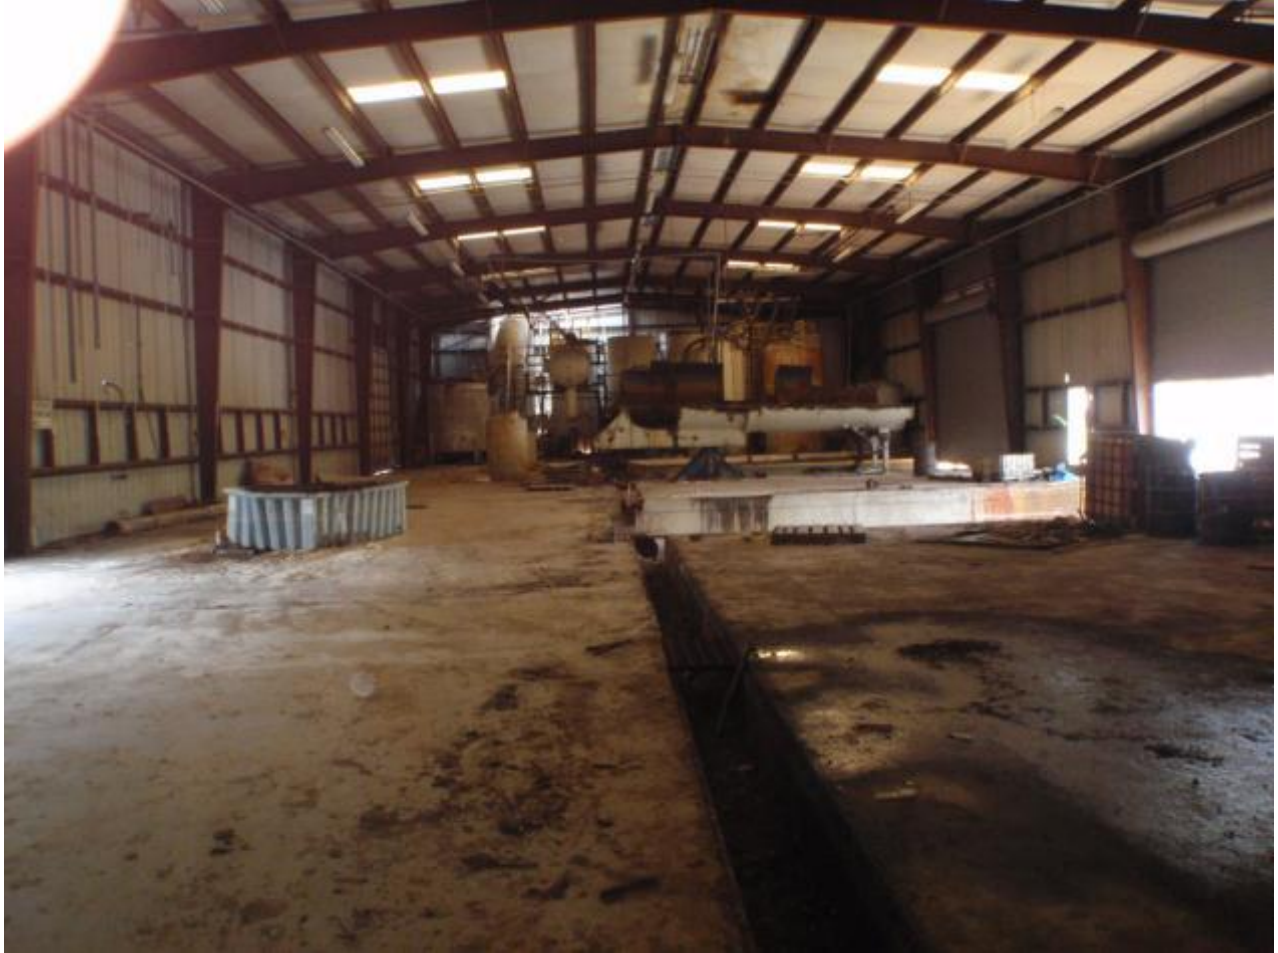
Photograph #25, August 12, 2014 - View looking north inside the large warehouse building. The white open top container in the left side of the photograph contains oil that was recovered from the loading bay. The loading bay that contains oil is lit up with sunlight. Behind it is the tank trailer that was reportedly the source of the oil in the loading bay. The tank trailer reportedly was cut up by thieves (metal recyclers). The facility's wastewater treatment system is visible in the background.

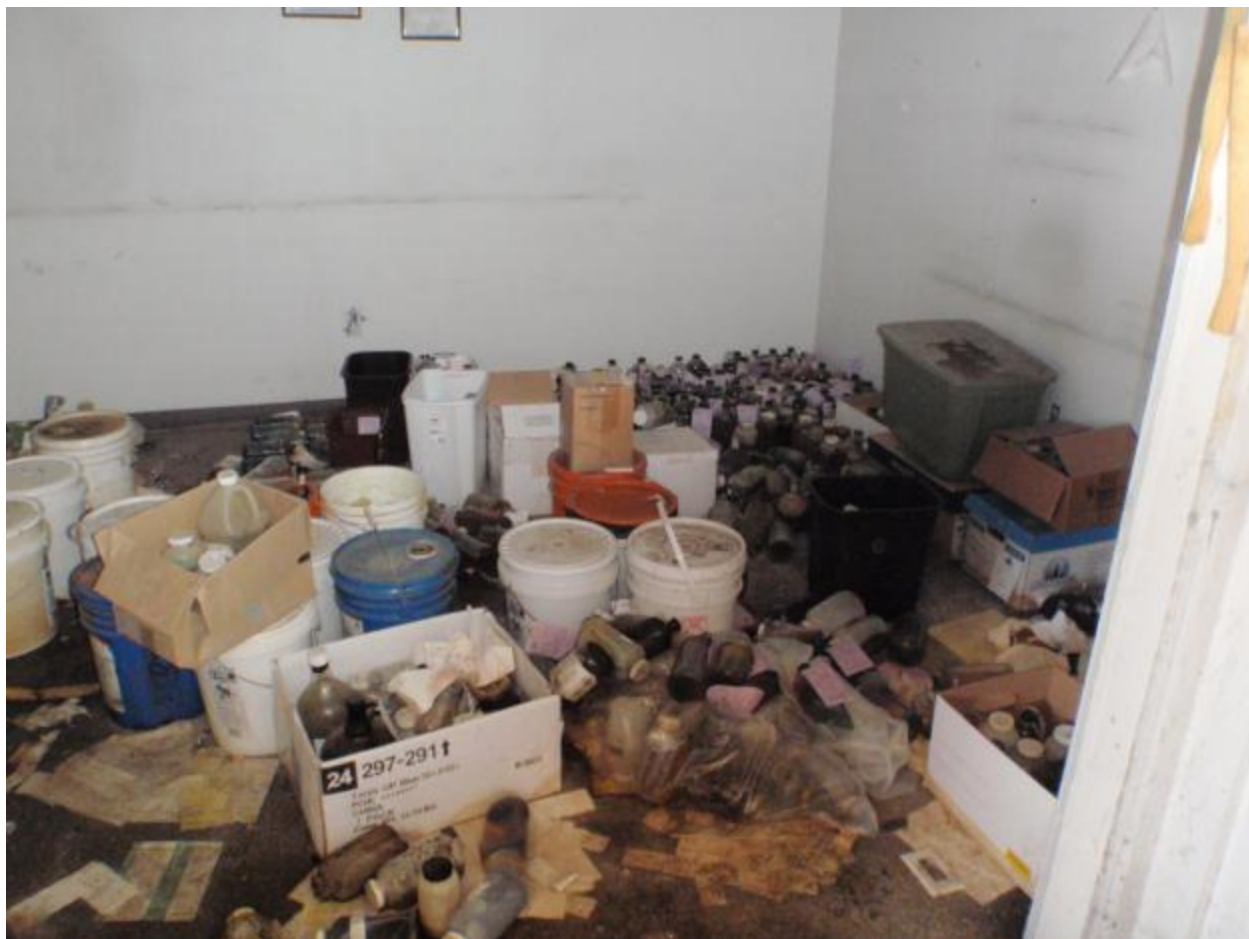
Photograph #26, August 12, 2014 - View looking southwest into one of the former laboratory rooms. The laboratory area is located in the south end of the large warehouse building.

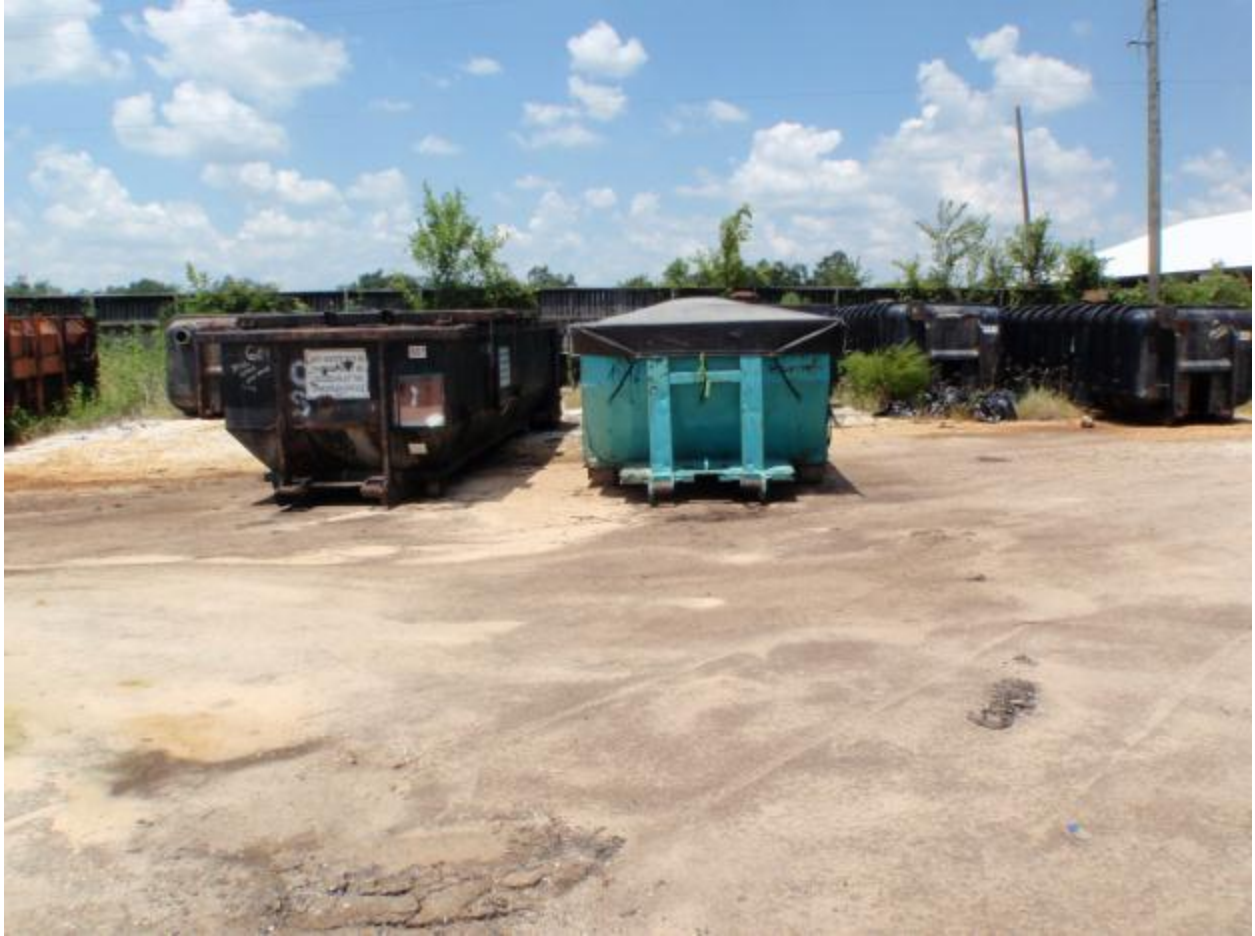
Photograph #27, August 12, 2014 - View looking west at the vacuum boxes that are staged along the western fence in the south part of the main facility. Waste from vacuum box 601 has reportedly been placed in the blue green roll-off box that is located just to the right of vacuum box 601.

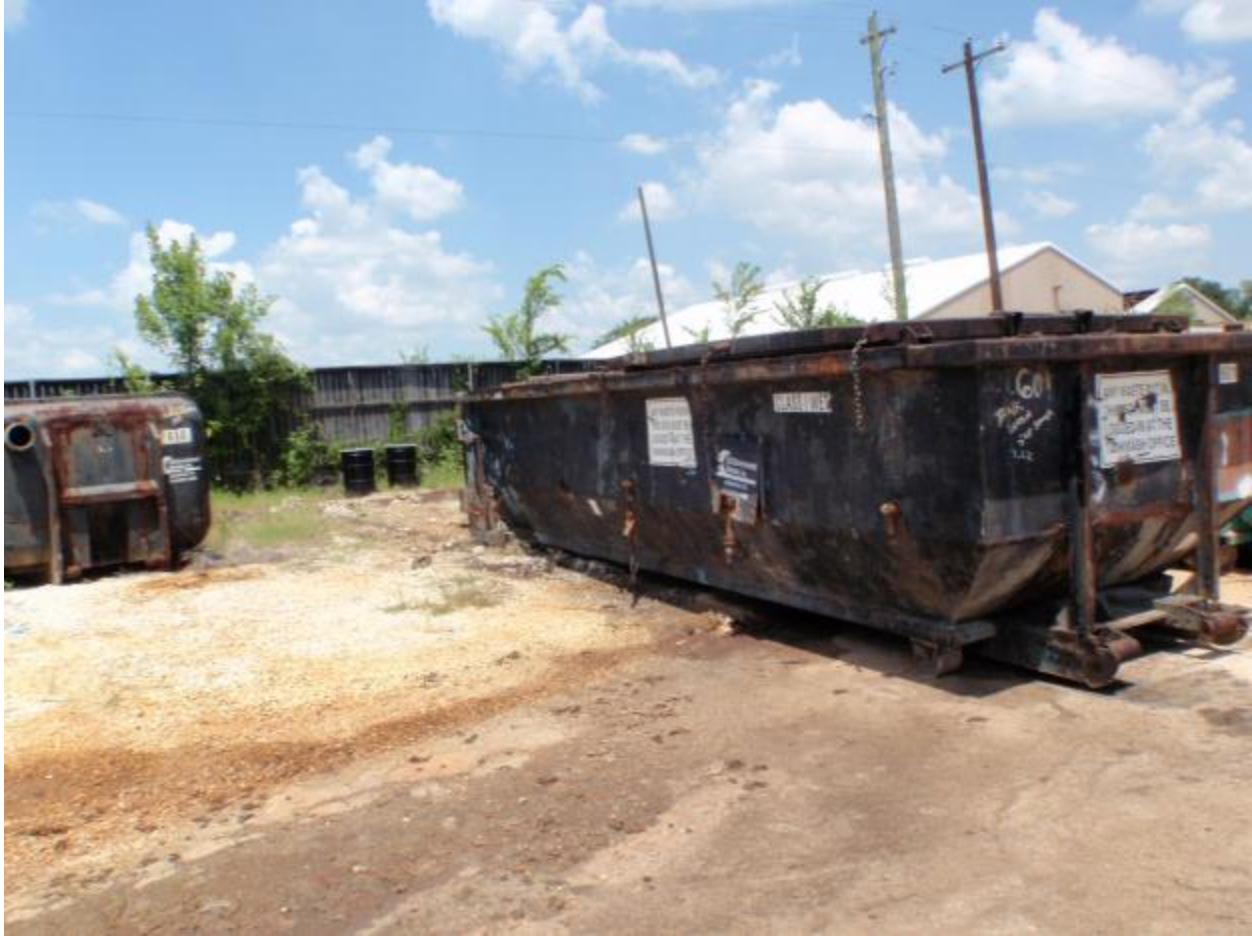
Photograph #28, August 12, 2014 - View looking west at vacuum box 601, which reportedly has been emptied. It appears that vacuum box 601 has been moved approximately 15 feet away from where it used to sit near the western perimeter fence (wooden fence in background).
